Codornices Creek Restoration Project

2011 Supplemental Monitoring Report

Phase 2 Vegetation Monitoring
Phase 3 Geomorphic Monitoring

City of Albany / City of Berkeley

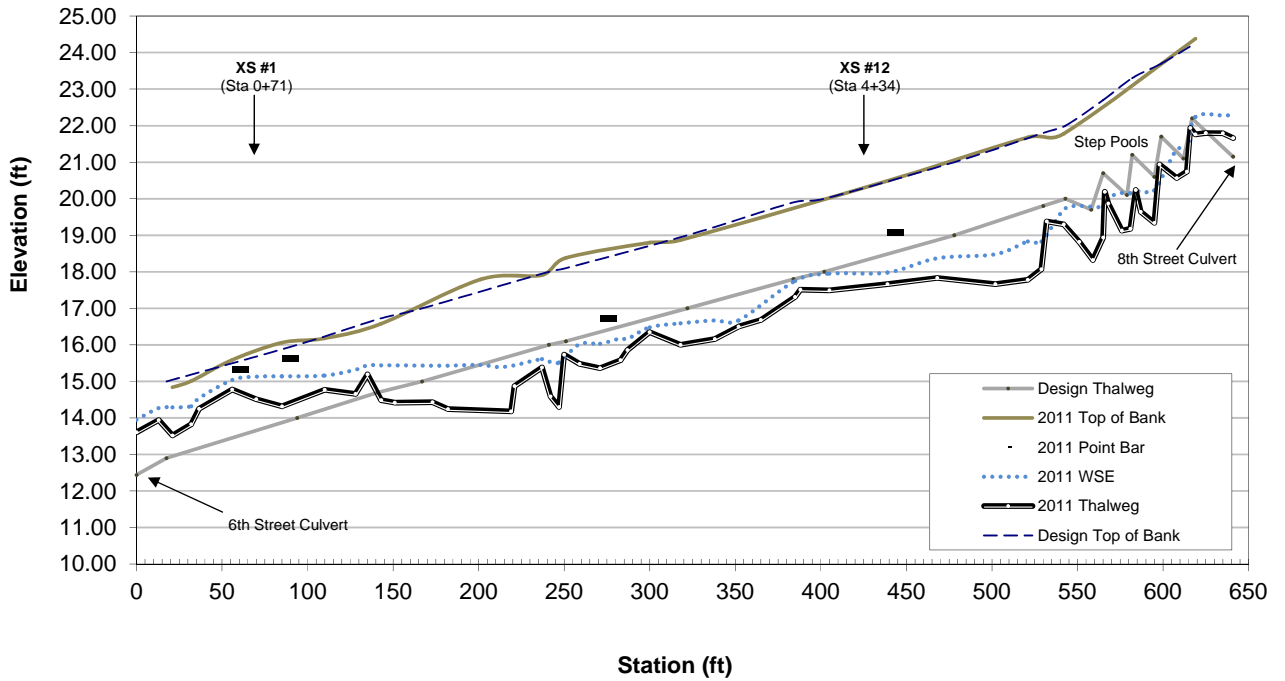
Channel Profile
Year 1 - 2011

The survey indicates the floodplain surface was built at the design elevations throughout the length of the project and it appears that the majority of the grade control structures were set lower than the design elevations. No as-built plans were available to reference, but it is assumed that the channel thalweg elevation was built slightly lower than the design elevation.

The survey verifies general site observations that the channel has scoured at the upstream end and aggraded at the downstream end. The upstream end of the project the channel has scoured to hardpan clay. Downstream the channel has deposited sediment in the channel and the floodplain where the 6th street culvert backwaters the creek during storm flows. The step pools at the upstream end of the project have remained stable.

Riffle and pool morphology have begun to develop within the channel with the exception of areas scoured to hardpan. The hardpan is hampering sediment deposition in these areas and limiting development of depositional feature such as point bars.

- 3.4.1. Continue to monitor the deposition at the downstream portion of the project site. If it appears 6th street culvert has limited capacity, treatments can be considered to improve sediment competency through the reach. This would include modifying the upstream end of the Phase 2 channel and/or removing material from the Phase 3 channel and placing it on the floodplain to increase the depth of the channel adjacent to the culvert. It should be noted that these are two items that are likely to occur on their own, so it is not recommended pursuing these options unless there is immediate concern over the culvert capacity.

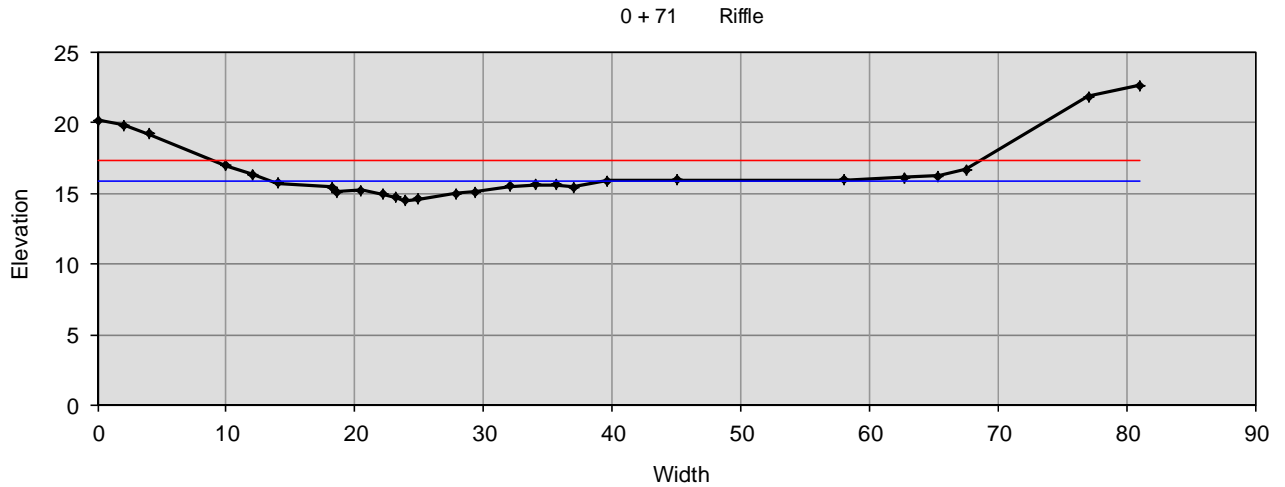
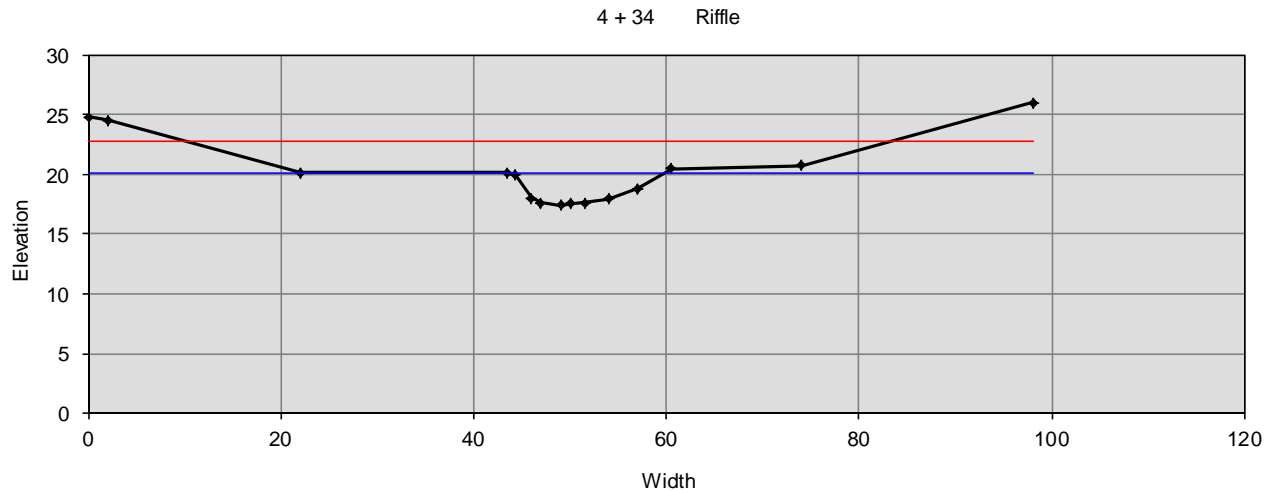
Two riffle cross sections were surveyed in the project reach. Cross section #1 is in the lower portion of the creek and is influenced by the culvert backwater. Cross section #2 is upstream in the location adjacent to the hardpan bed. Both cross sections were marked in the field with rebar and will be resurveyed in future years for purposes of comparison.

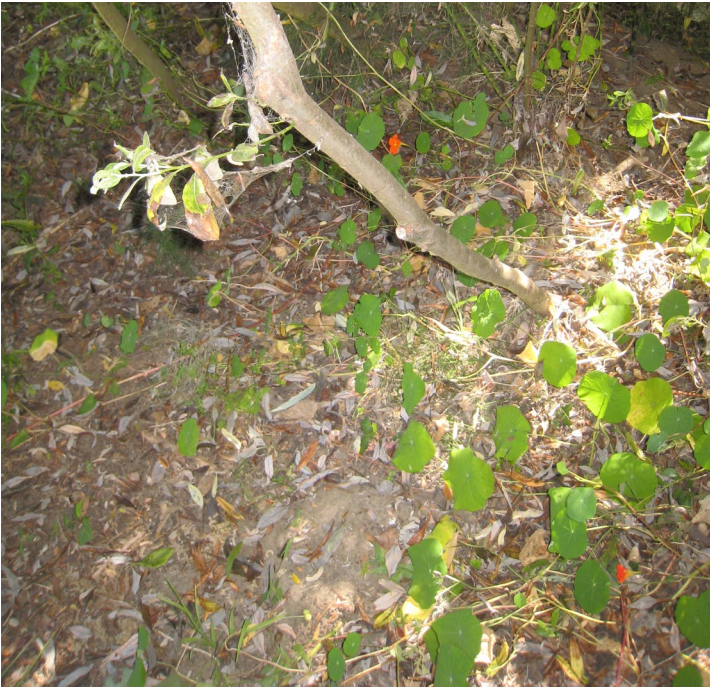
The 2011 survey of percent cover indicates a significant increase in bare ground and a decrease in native species. This was primarily due to over half of the survey plots falling underneath the riparian canopy. It was observed that these plots were dominated by bare ground and invasive species such as bindweed and nasturtium.

The greatest difference between 2011 monitoring and subsequent years is the dominance of the willow canopy. Prior to 2011 the survey plots sampled open areas on the banks and floodplains. In 2011 there were not enough locations outside of the riparian canopy, therefore many of the plots were surveyed under the canopy. This had a dramatic effect on the results. Plots under the riparian canopy were dominated by bare ground.

PHASE 2: Nasturtium and bare ground under willow canopy - 9.22.11

- 2.5.1. Remove acacia on left bank.
- 2.5.2. Remove Algerian ivy. Patches are expanding and should be controlled immediately.
- 2.5.3. Actively remove bindweed where climbing on willows and trees.
- 2.5.4. Locate and remove Himalayan blackberry. Numerous small patches exist throughout the site with larger patches on the left bank.
- 2.5.5. Remove nasturtium.
- 2.5.6. Empty trash cans on-site more frequently.
- 2.5.7. Remove trash dumped under bridges and along the channel.
- 2.5.8. Plant under the willow canopy with shade tolerant species. The site has matured to a degree suitable for more shade tolerant species. This is an activity that could be taken on by volunteers such as the Codornices Creek Watershed Council and would increase plant diversity on-site.

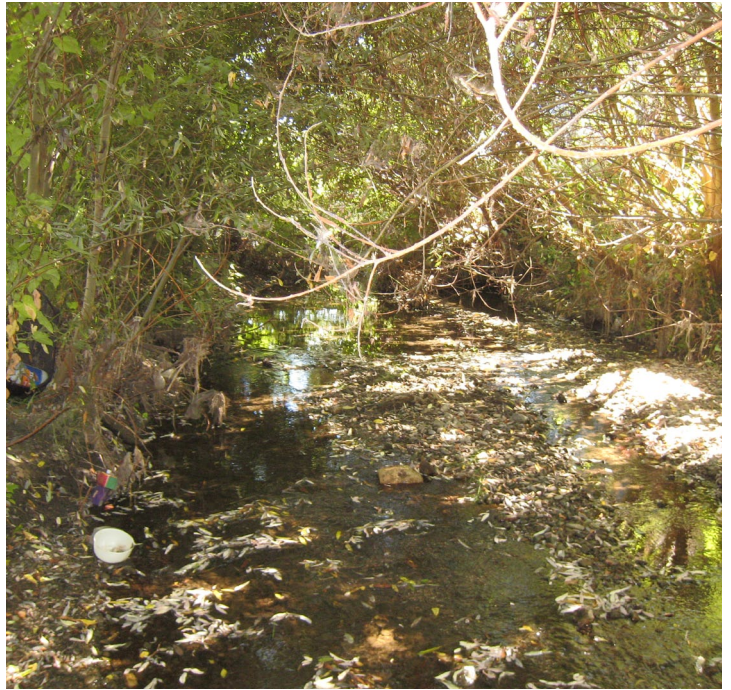
The willow used for soil bioengineering is healthy and robust. No bare areas were observed except directly under the Fifth Street bridge. The willows are growing vigorously, approaching 25-feet in height and have formed a complete canopy over the creek--as a result no watercress and cattails were observed. This is in stark contrast to site conditions two years ago, where much of the channel was colonized by cattails and watercress.

PHASE 2: Mature willow canopy encloses entire creek channel - 9.22.11

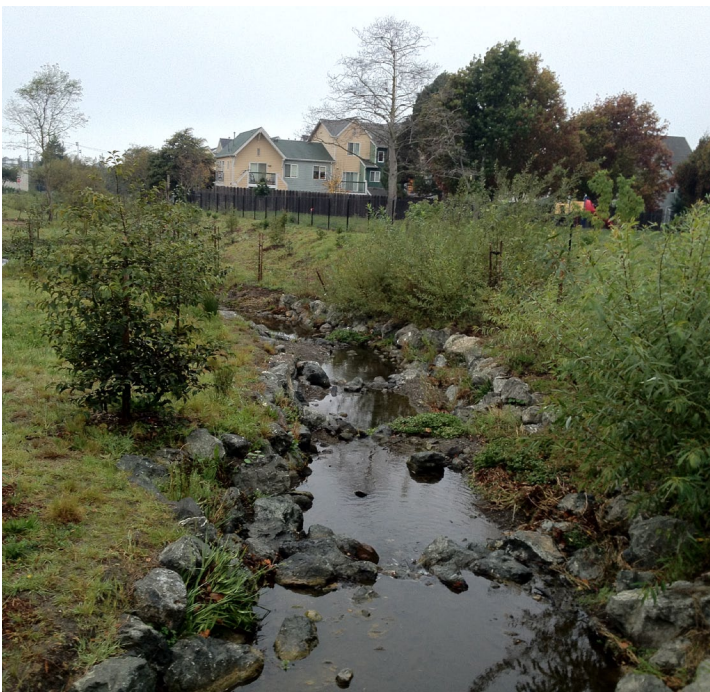
PHASE 3: Step pool channel below 8th Street Culvert - 10.24.11

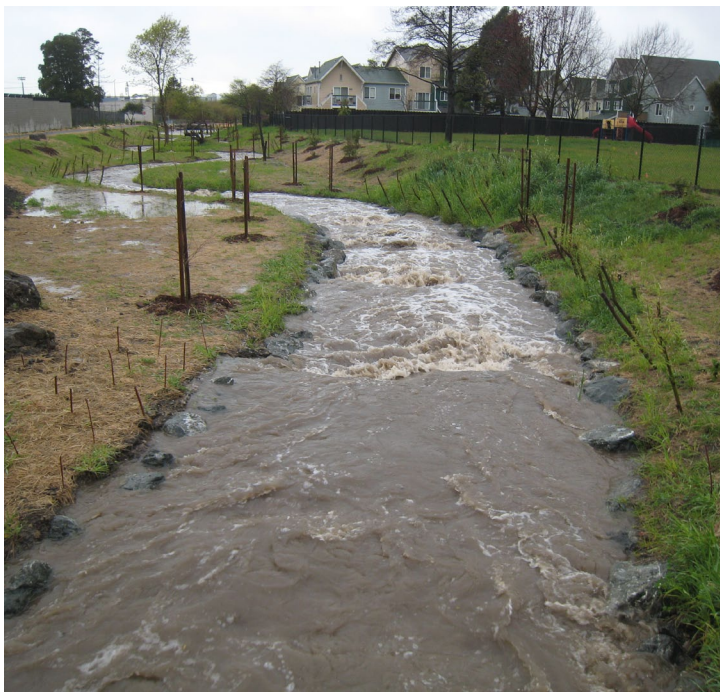
PHASE 3: Step Pool channel during high flows - 2.17.2011

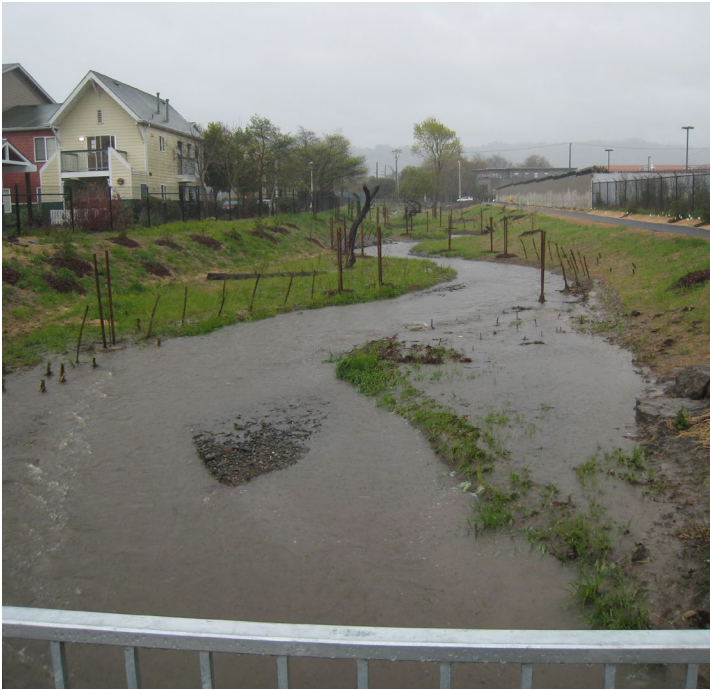
PHASE 3: Looking upstream from 6th street during high flows - 9.17.11

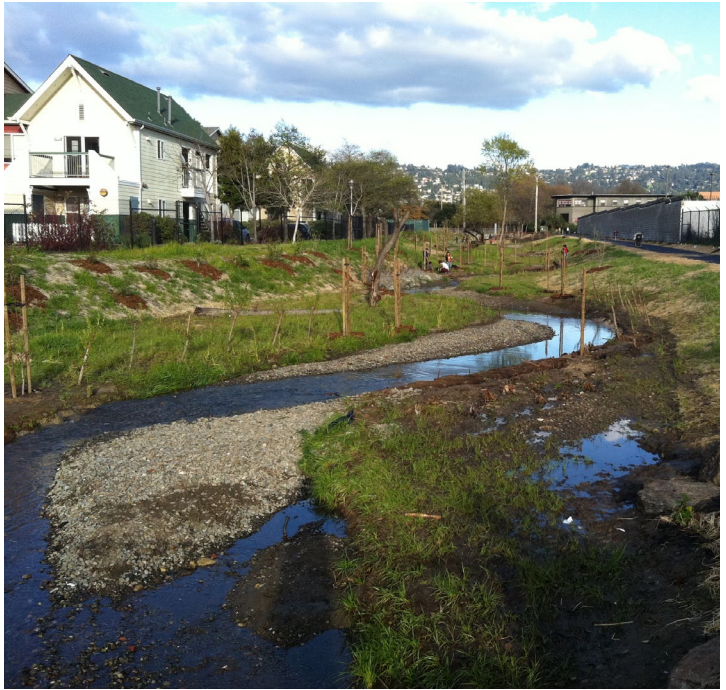
PHASE 3: Looking upstream from 6th Street after construction - 2.21.11

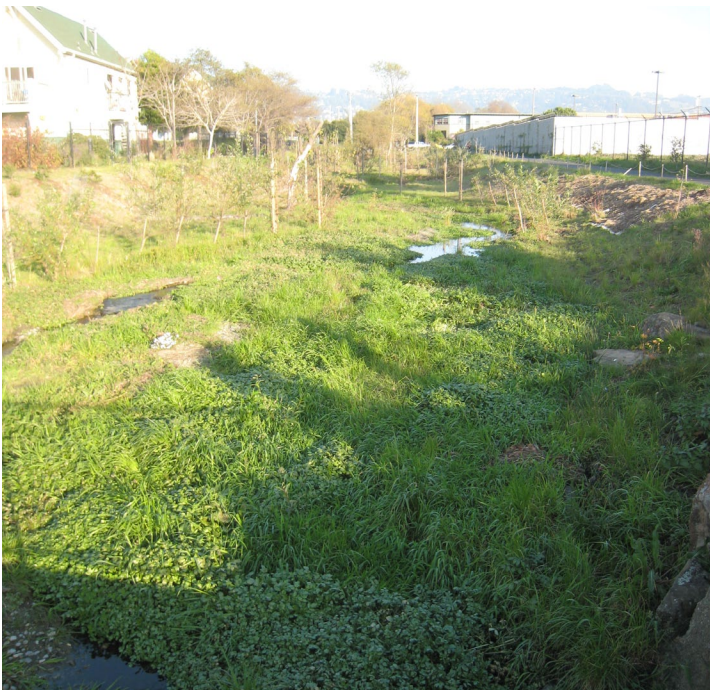
PHASE 3: Looking upstream from 6th Street - 12.8.11

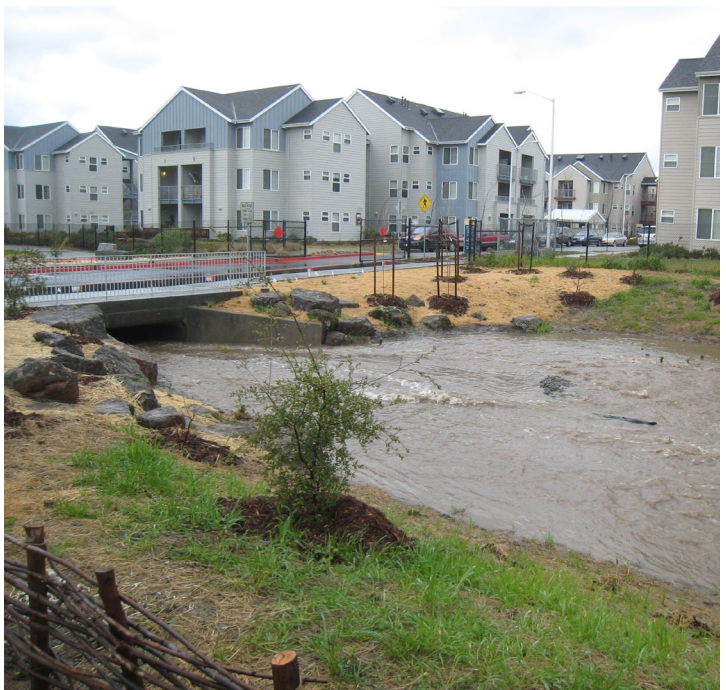
It is unknown if the current condition of the culvert has more or less conveyance than the pre-existing conditions. Although it appears there is more sediment in the bottom of the culvert today than prior to the project, the headwall was raised approximately 10 inches

The cause of the aggradation in this area is likely due to two conditions. The first condition is the backwater effect from the culvert, slowing the velocities behind the culvert and reducing the competency to move sediment in this location. The second condition is aggradation within the upstream portion of Phase 2, which has raised the tie-in elevation for Phase 3. This higher elevation of Phase 2 reduces the slope through the culvert and downstream portion of Phase 3 adding to the reduction in competency to transport sediment in the lower section of Phase 3.

PHASE 3: Channel entering 6th street culvert during storm - 2.17.2011
