Codornices Creek Restoration Project

2013 Supplemental Monitoring Report

Phase 3 Vegetation Monitoring
Phase 3 Geomorphic Monitoring

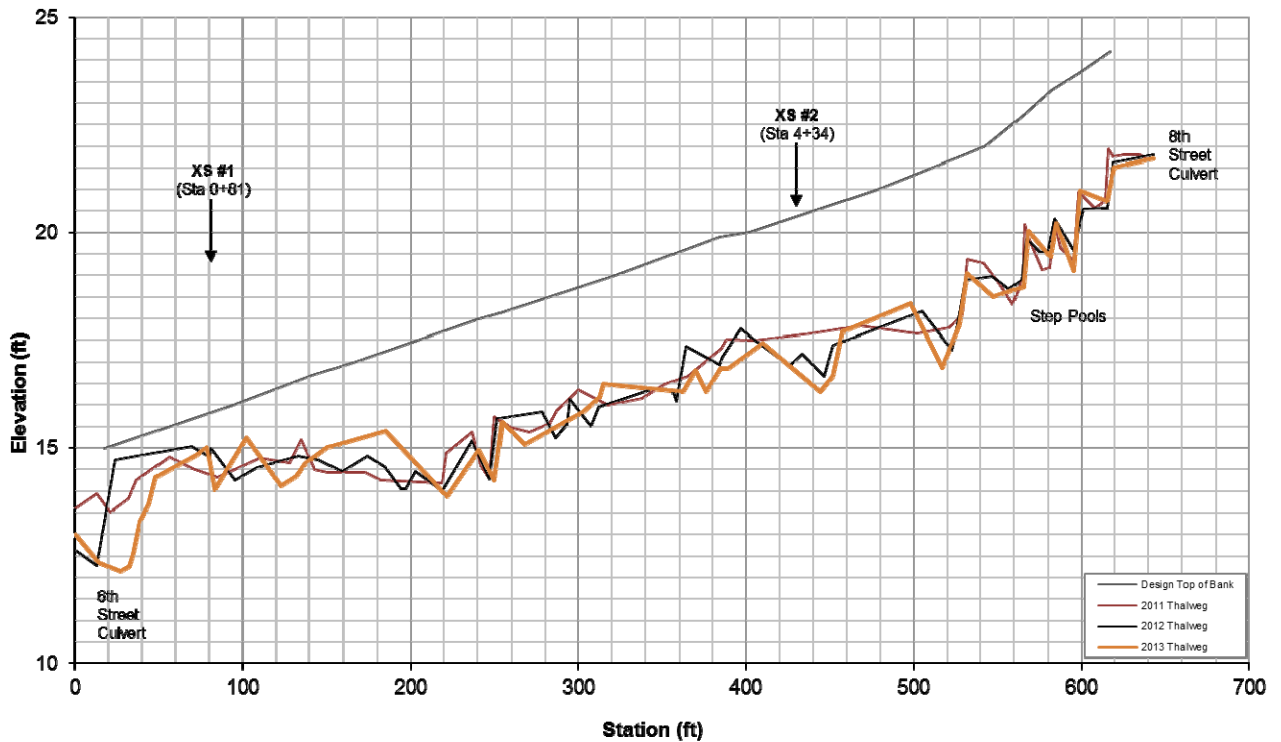
Codornices Creek Phase III
Channel Profile

Winter 2012/2013 saw similar adjustment and change as Winter 2011/2012 in Phase 3. Much of the bed has maintained a consistent elevation. The channel adjustments that occurred during the first winter upstream of the 6th street culvert have slowed and the channel has recreated a single threaded channel in this area. The upstream step pools have remained stable.

Riffle and pool morphology continue to develop within the channel with the exception of areas scoured to hardpan. The hardpan is hampering sediment deposition in these areas and limiting development of depositional feature such as point bars. Emergent vegetation was thick during the summer and led to minor sedimentation within the active channel.

The area immediately upstream of the 6th Street culvert has shown the most change since construction. The creek has abandoned the meander on the right and instead cut through the left point bar. The 2013 long profile show the original stationing through the design channel. The area immediately upstream of the culvert has experienced aggradation due to backwatering at the culvert during storm events. As in 2012, this backwater flooded the floodplain and lowered discharge velocities causing sediment deposition in the channel. This aggradation lowered the channel profile slope and further reduced the competency of the channel to pass sediment. There are indications that the deposition at the downstream end is working towards an equilibrium condition. The deposition has elevated the floodplain in this area and a low flow channel has recently reformed. No intervention is required at this time.

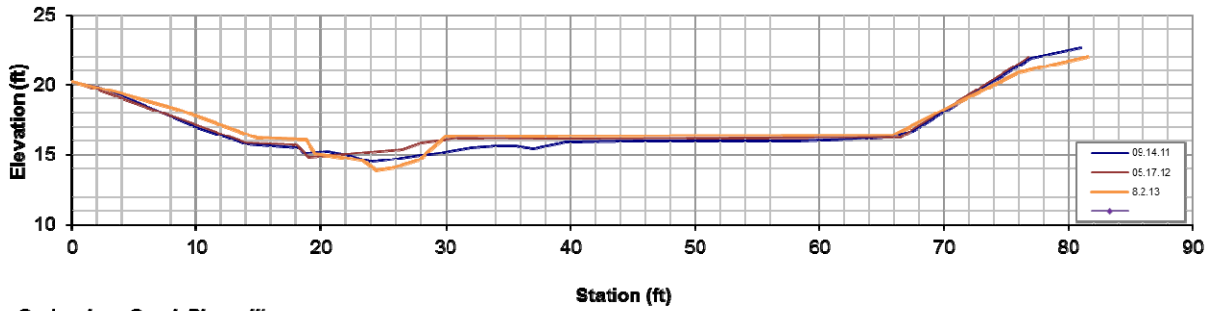
Codornices Creek Phase III
 Cross Section 1
 Profile Station 0+81

The two riffle cross sections were resurveyed in 2013. Cross section #1 is in the lower portion of the creek and is influenced by the culvert backwater. Cross section #2 is upstream in the location adjacent to the hardpan bed. Cross section 1 shows continued adjustment of the channel above the 6th street culvert. It continues to maintain the floodplain bench it established in 2012 (perhaps aggrading slightly), but the active channel has incised slightly. Cross section 2 has maintained its inner depositional bench formed in 2012 and incised its thalweg slightly, but otherwise remains similar to the 2011 and 2012 surveys.

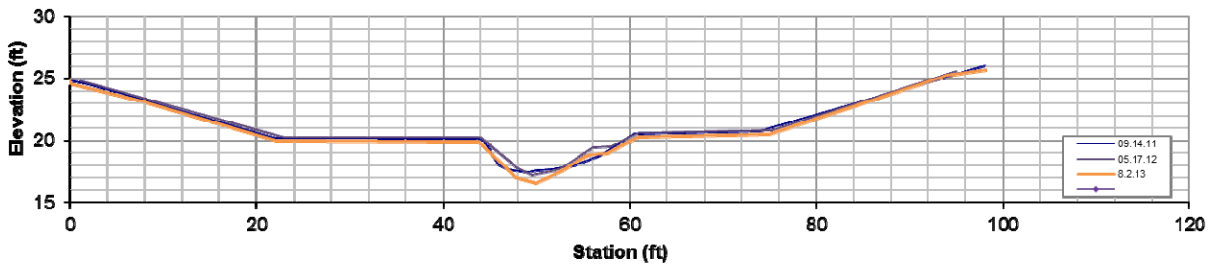
Codornices Creek Phase III
 Cross Section 2
 Profile Station 4+34

The exposed hardpan upstream continues to persist. This hardpan substrate excludes any opportunity for hyporheic flow and does not provide ideal habitat for benthos. This

- 3.4.1. Consider addressing the channel hardpan at the upper half of Phase 3 by adding rock to construct riffles that raise the channel grade back to the designed hydraulic geometry.

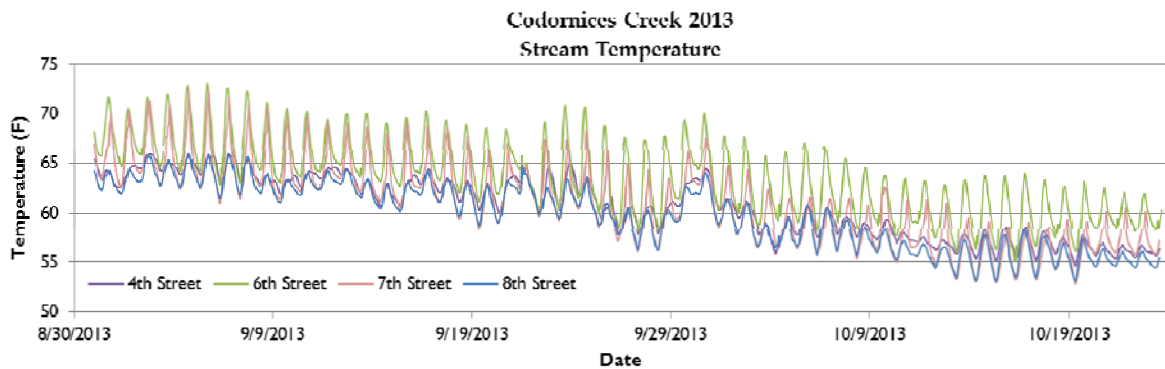
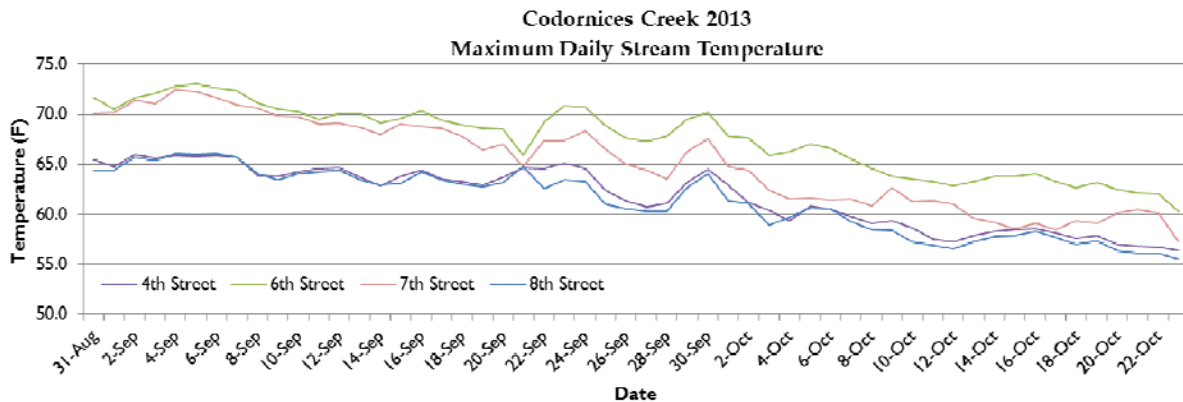
Average and maximum stream temperatures are higher within and immediately downstream of the Phase 3 restoration project. Temperatures downstream of the project, at 4th Street, are largely similar to 8th street indicating that much of the warming that occurred within the Phase 3 is sufficiently dampened before reaching the 4th Street data logger.
