Codornices Creek Restoration Project

2020 Monitoring Report

City of Albany / City of Berkeley

Codornices Creek Monitoring 2020

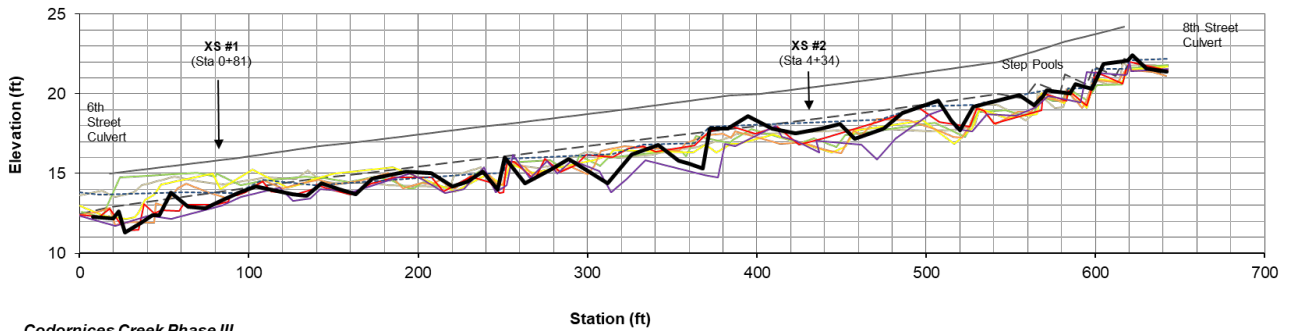
Codornices Creek Phase III
Channel Profile

Riffle and pool morphology continue to develop within the channel as seen in the long profile surveyed in 2020. Woody debris in channel has helped accumulate coarse sediment and reduce scour in some areas. However, hardpan continues to reduce sediment retention and disrupt the formation of point bars. There continues to be some areas of concern where channel degradation has occurred near where the hardpan has been exposed. However, some deeply scoured pools have remained stable or filled in with sediment showing some improvement since 2019.

The exposed hardpan upstream continues to persist but has begun to be buried by sediment being trapped behind woody debris crossing the channel. The long profile shows between 6" and 1' of aggradation above STA 3+00 which is a significant improvement from the survey in early 2019. Willow branches and other woody plant matter should continue to be encouraged to build-up in the channel. This technique, often referred to as a Beaver Dam Analog (BDA), will increase sediment deposition and create connection between the channel and floodplain by dispersing flow horizontally.

3.3.1. Allow vegetation to remain in the channel to encourage minor debris jams and backwatered pool habitat. Use small limbs pruned off willows and place downstream of pools perpendicular to channel.

3.3.2. Consider actively installing woody debris jams similar to Beaver Dam Analogs to accelerate deposition within this reach.

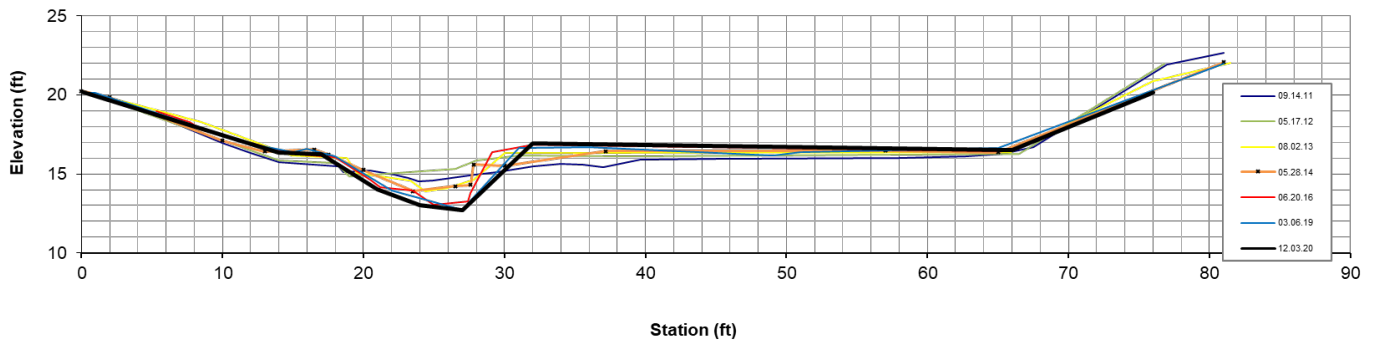
Codornices Creek Phase III
 Cross Section 1
 Profile Station 0+81

The two riffle cross sections were resurveyed in 2020. Cross section #1 is in the lower portion of the creek and is influenced by the culvert backwater. Cross section #2 is upstream in the location adjacent to the hardpan bed. Cross section 1 has remained stable after narrowing the first four year after construction. Cross section 2 has also remained stable after building an inner depositional bench the first four years after construction. The thalweg has maintained a consistent elevation for the duration of the monitoring period.
