## Technical Memorandum

### Codornices Creek Post-Project Habitat Reconnaissance

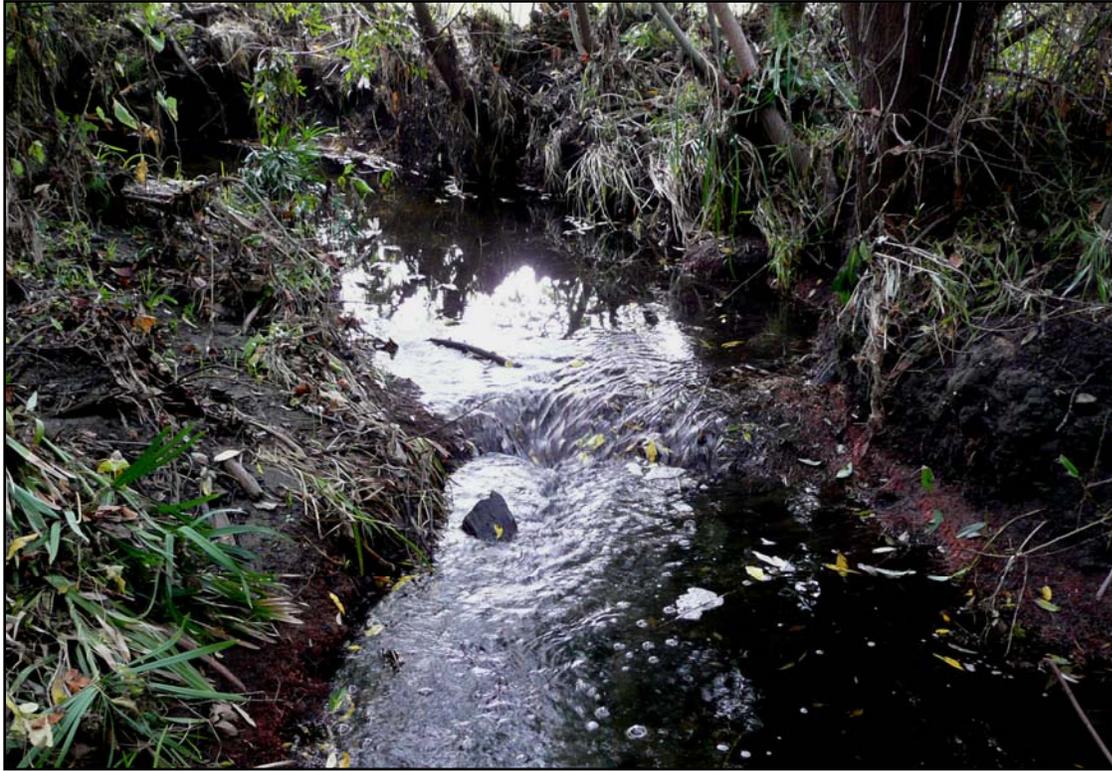
There were no significant migration obstacles in the survey reach although, due to the stream's small size, passage through riffles would be limited under baseflow conditions. The pool tail/riffle head areas were generally about 0.2 feet deep. The most critical riffle observed was a steep drop over a willow root mat that averaged about 0.1 feet deep (Photo 1). These conditions are to be expected in a stream the size of Codornices Creek with adult steelhead migration passage limited to periods of storm runoff. The relatively narrow width and steep banks of the low-flow channel should result in a relatively large increase in flow depth with increases in streamflow at these riffles.

Photo 1. Critical passage riffle formed by willow root mat.
