Codornices Creek
Fish Passage and Habitat
Improvement Project

Conceptual Restoration Plan
San Pablo Avenue to Monterey Avenue

Codornices Creek
Berkeley, California

May 2005

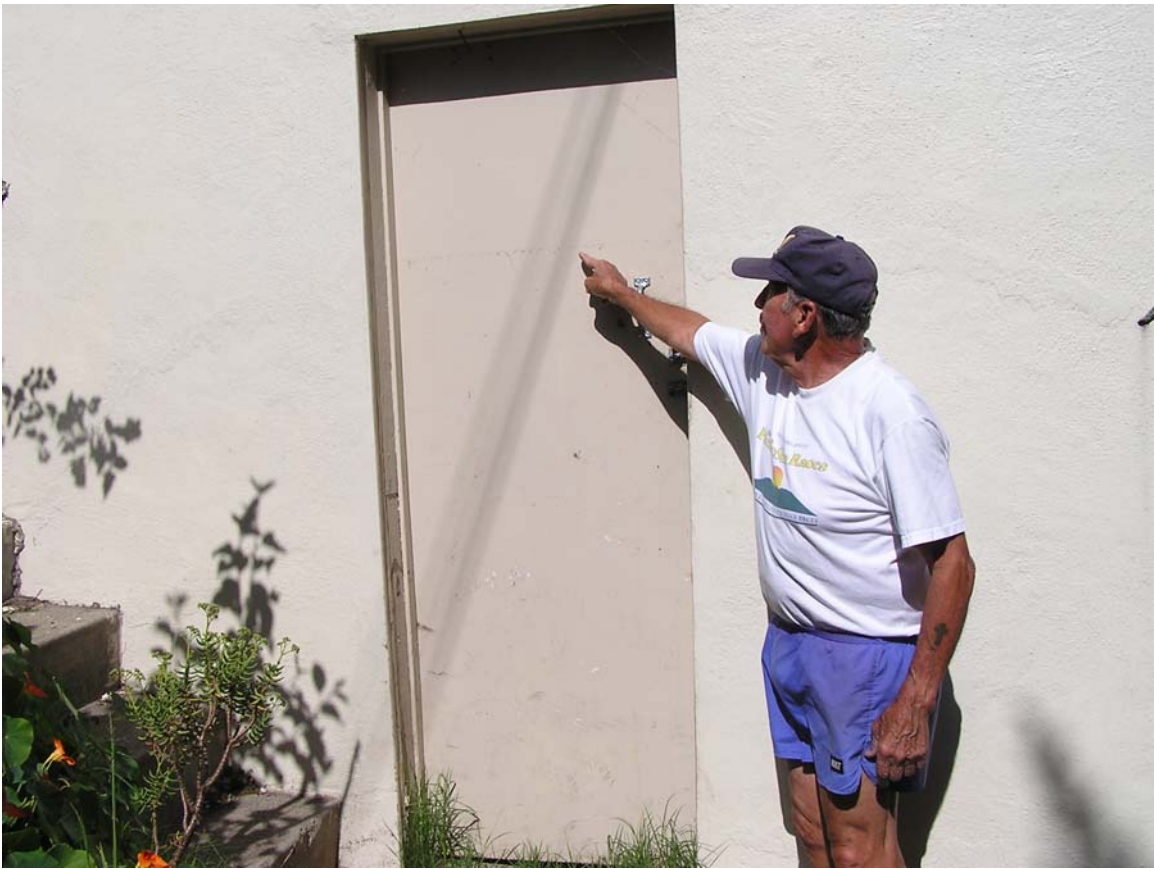
Figure 2. Flooding elevation, as indicated by debris line on a resident's door, experienced upstream of the Cornell Avenue culvert in a January 2004 storm.

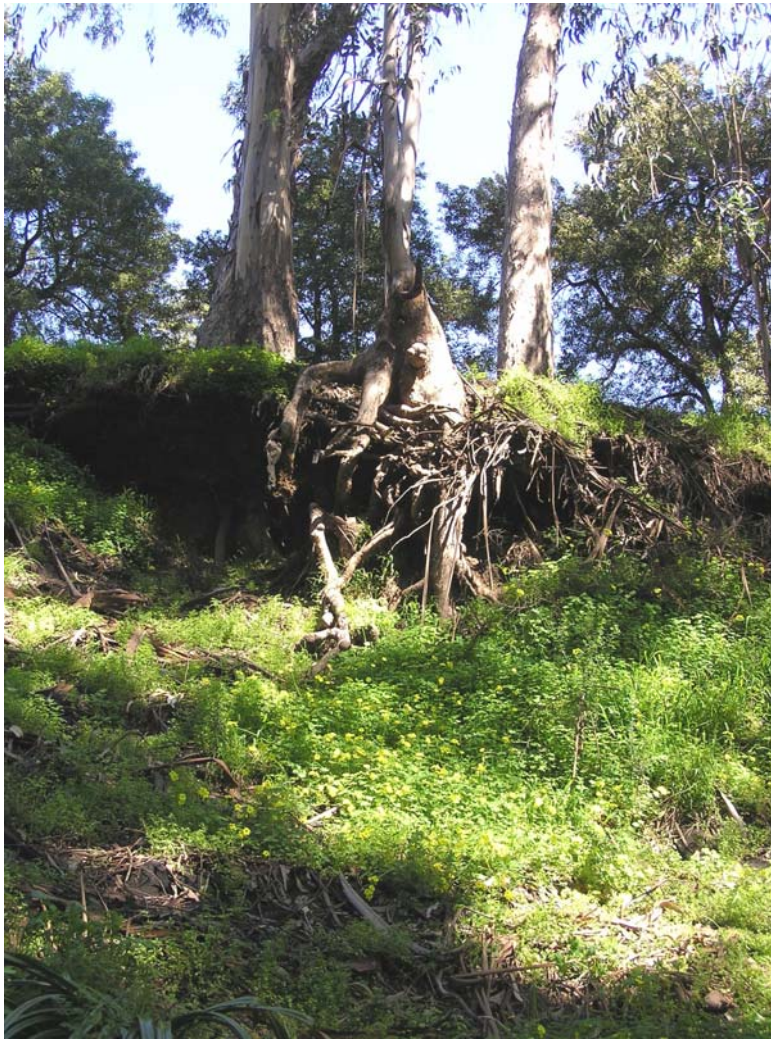
Figure 17. Undercut Eucalyptus trees along the top of right bank at St. Mary's College High School.

Figure 18. Typical section view of bank stabilization proposed for St. Mary's College High School to reduce erosion and sedimentation of Codornices Creek. The existing eucalyptus trees are to be removed, the bank resloped, a curb installed adjacent to the driveway, and native vegetation species planted throughout.

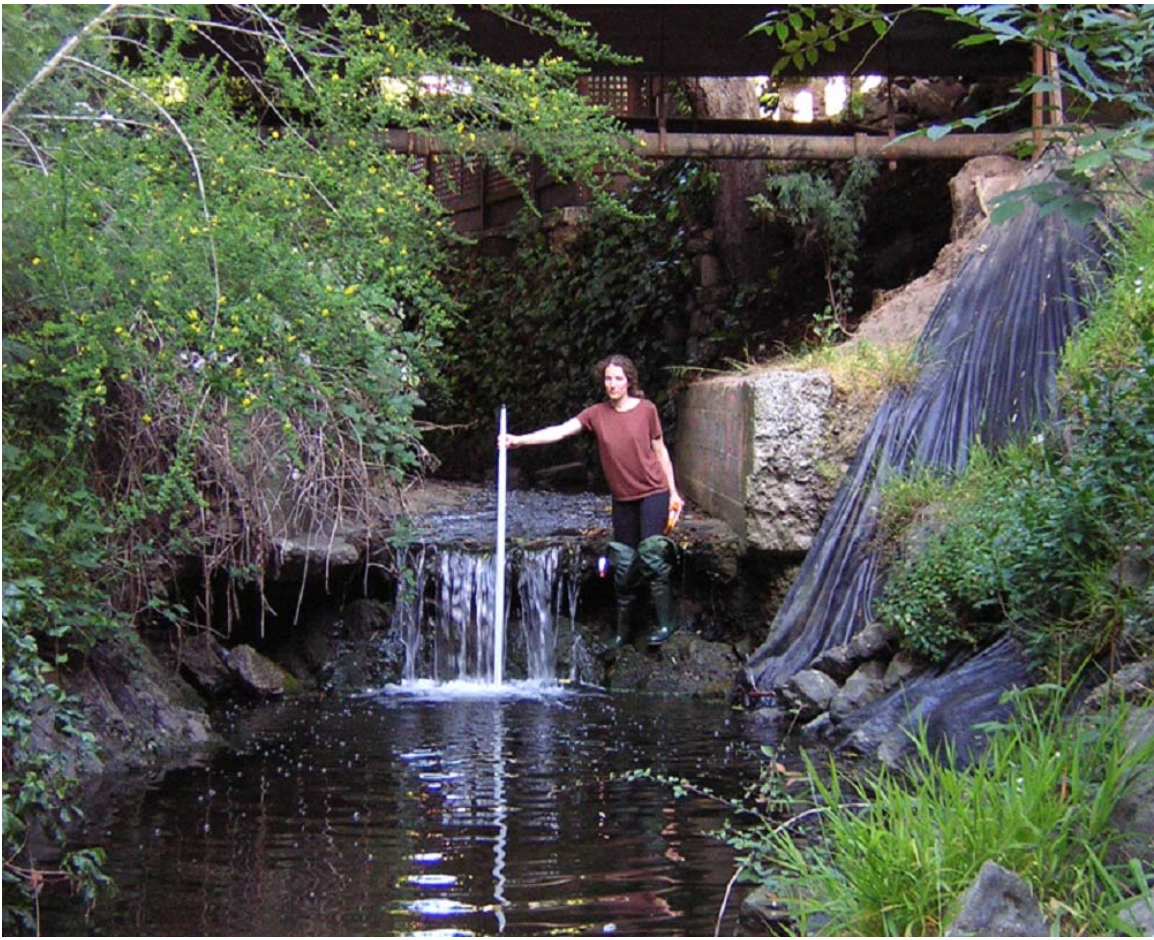
Figure 19. Albina Avenue Bridge crossing and the 4' plunge pool at the outfall.

The proposed barrier modification to the Albina Street Bridge crossing involves the installation of a downstream step-pool system to allow fish to pass through a series of cross-vein rock weirs and into the bridge crossing. Two alternatives were developed under this agreement. Alternative A requires eight step-pools and results in a slight backwater effect at the outlet end of the bridge. Alternative B does not provide for backwatering of the bridge bottom and involves less fill within the creek than Alternative A. For fish passage, Alternative A is preferred as it provides better conditions for migration due to its backwatering effect. However, as discussed below, this results in a higher impact on hydraulic conveyance through the bridge.

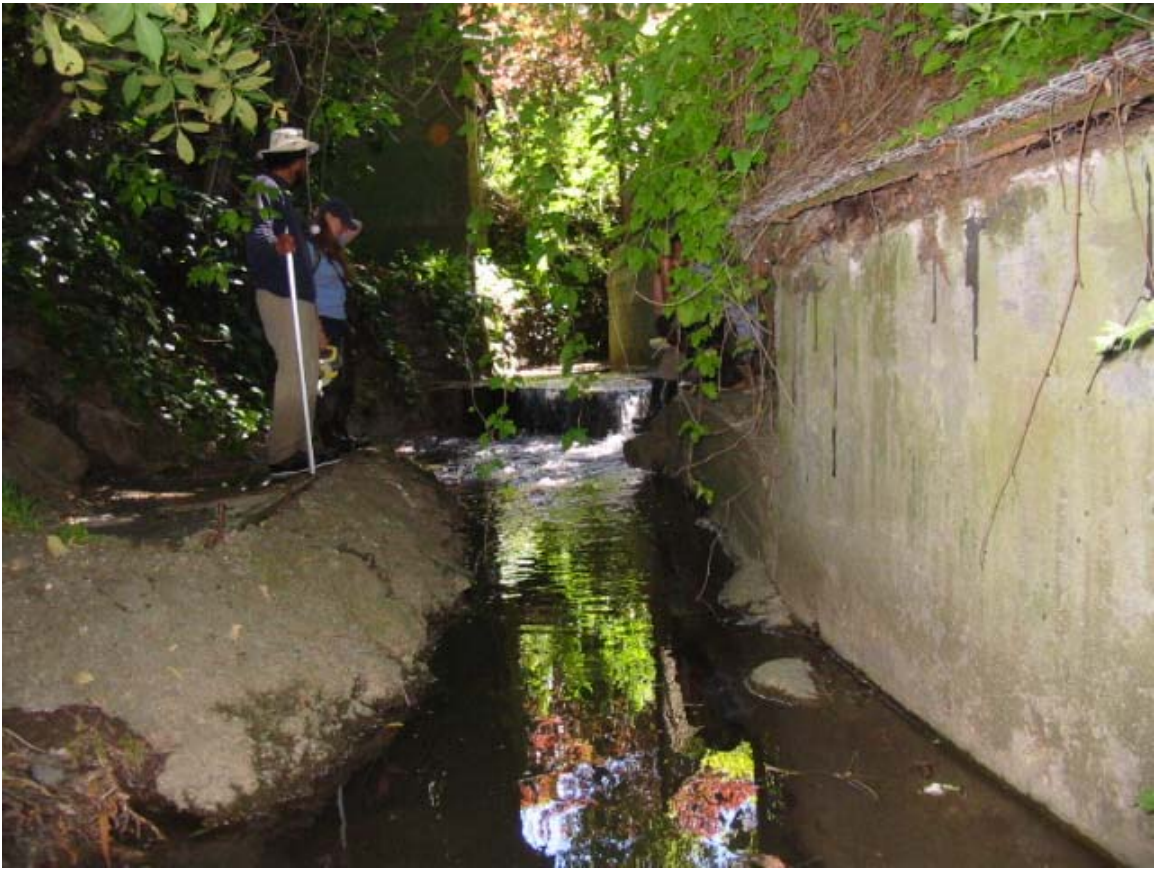
The concrete section is approximately 8 feet wide and extends from edge to edge in the creek channel and likely acts as a structural support to the adjacent creek channel walls. The existing retaining walls forming the sides of the straightened channel are a mixture of concrete and rock rubble walls, some of which look to be very old and in mixed condition.

The thickness of the base concrete is unknown but there has been some breakage of the concrete bottom in a few locations. More detailed coring and structural analysis of the condition of the concrete bottom will be required before proceeding through final design into construction.

Figure 22. Concrete step, 1.6' in height, at the downstream edge a straightened concrete lined channel. The concrete channel begins at the outfall of the Monterey Avenue culvert and extends downstream for 232'.

Figure 23. Plan view of engineered log structure and baffles to be installed to modify the concrete channel which acts as an existing barrier to fish passage.

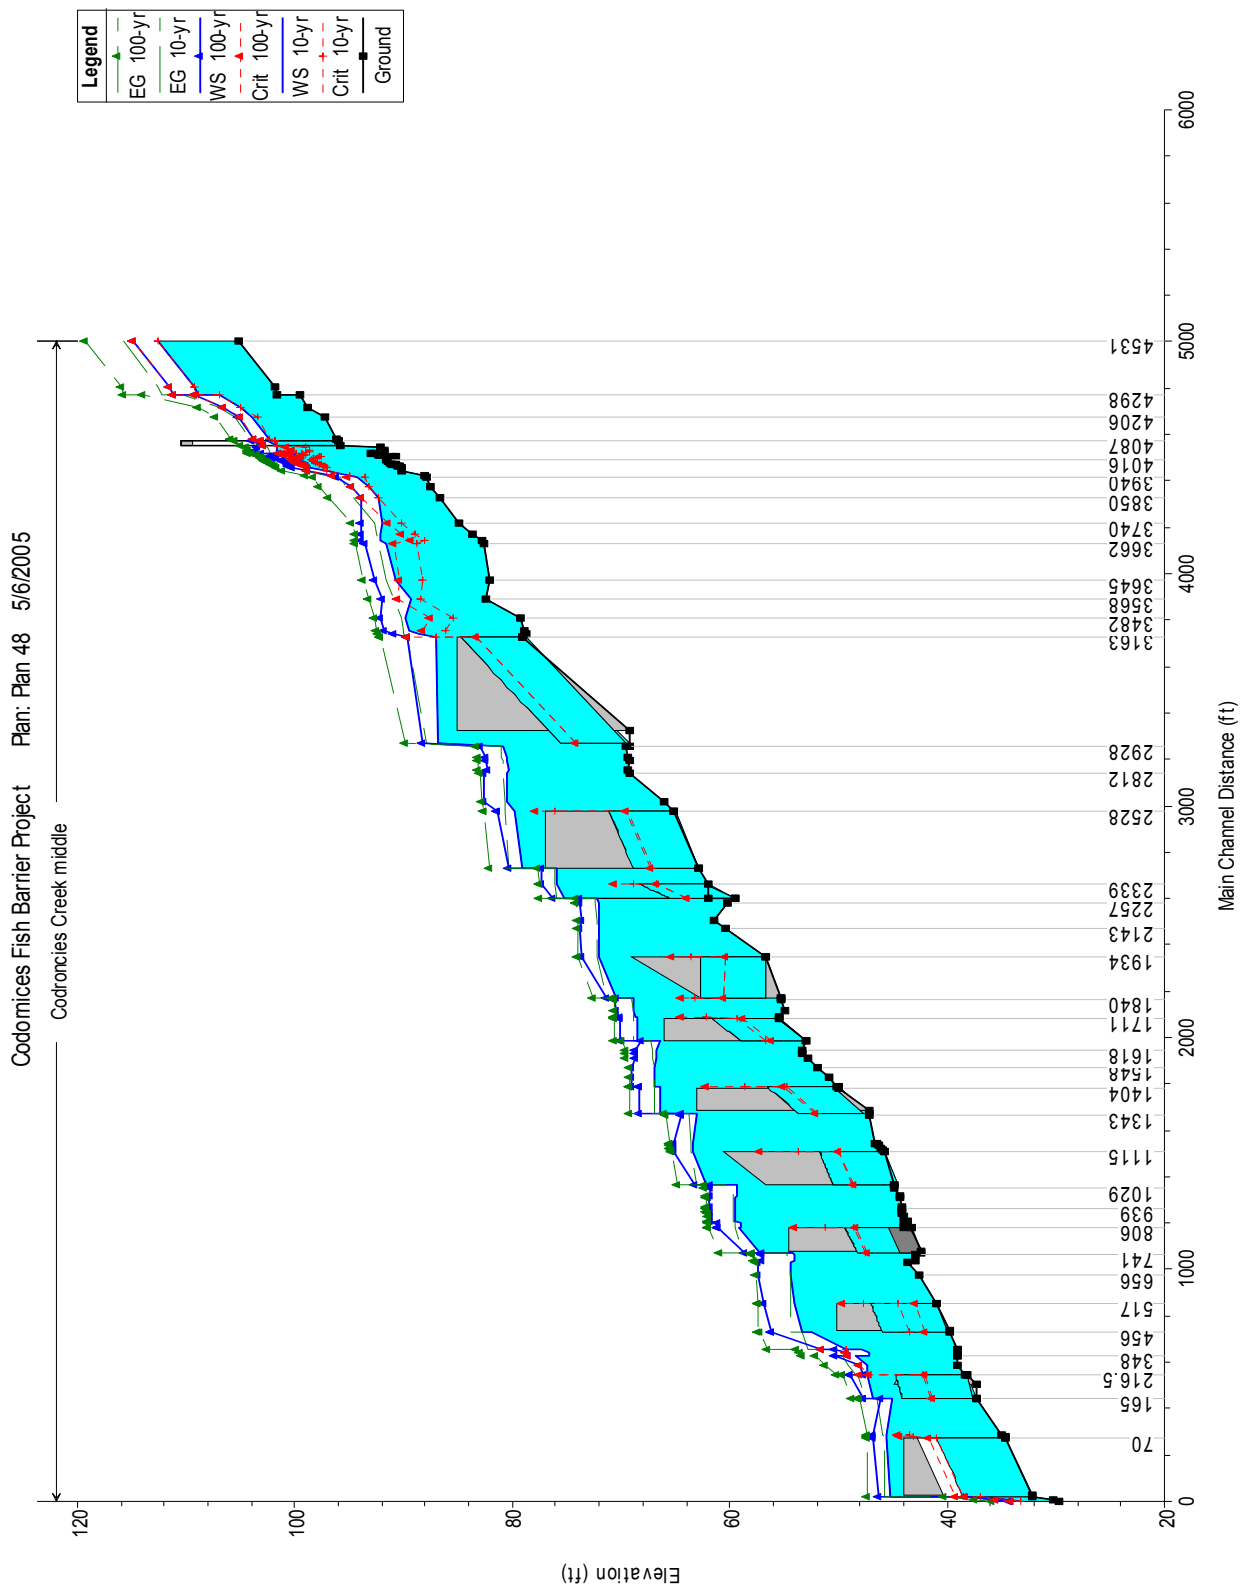
Figure 2 shows the calculated water surface elevations through the project site under existing conditions. The results indicate that there is existing flooding at all the culvert locations under 10-year storm existing conditions. Note that previous hydraulic analysis by the City of Albany (October 1998) also confirmed this finding.

Figure 2: 10-year and 100-year Existing Conditions Water Levels
Appendix B

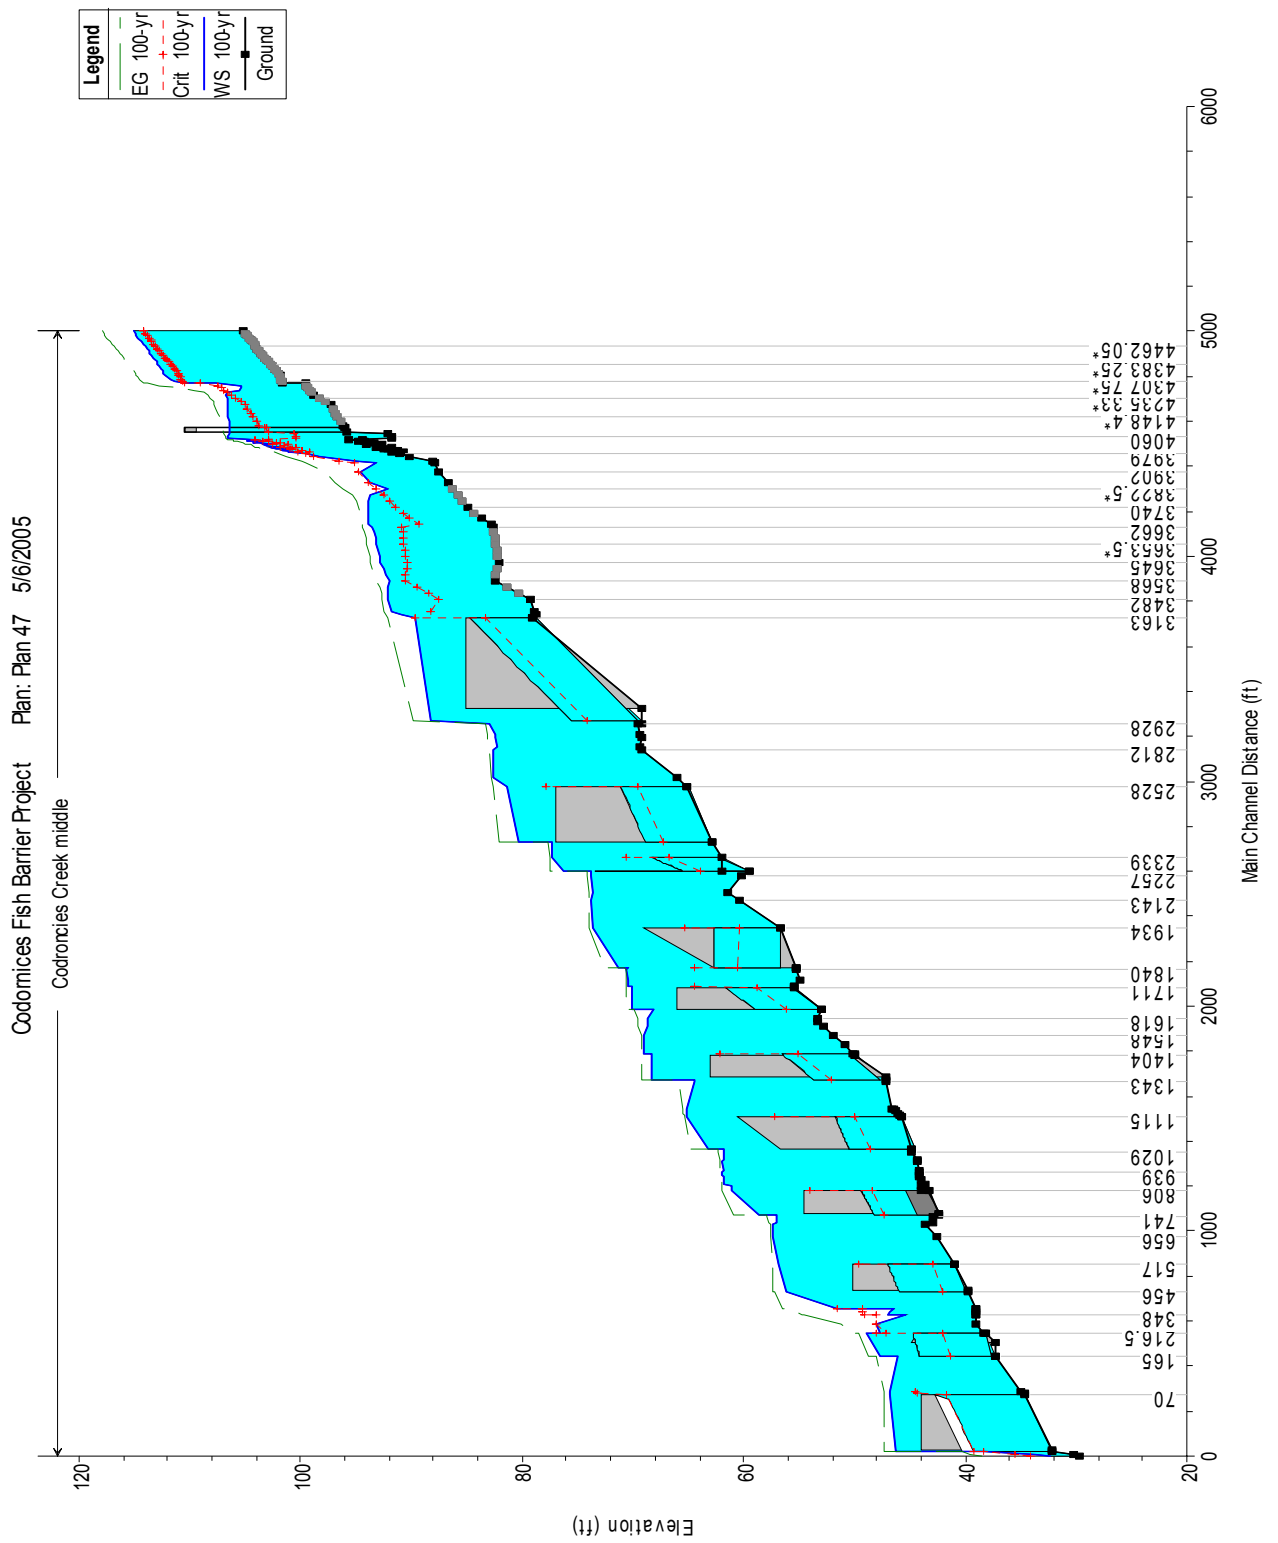
The results indicate a potential increase in water levels from 5 to 18 inches due to barrier modification implementation depending on the assumption method. Note that the flood model does not account for the effects of debris collection on the baffles. Debris blockage is a primary cause of backwater flooding of culverts and would be worsened by the installation of baffles within the culvert.

Figure 3 shows the 100-year calculated water surface elevations through the project site under the proposed restoration conditions by analyzing the seven selected culverts, using two methods; 1) embedding the culvert to the depth of the baffle and increasing the Manning's n value to 0.04 and 2) increasing Manning's n to a value of 0.07 in accordance with preliminary measurements obtained in baffled culverts by Washington State Department of Natural Resources staff. The results indicate that there would be a rise in water surface elevation of 8- to 15 inches due to the baffle installation in most of the culverts. Since there is no spare capacity in the culverts under current conditions, it is anticipated that baffles might increase an existing flooding problem. Figure 4 shows the water surface elevations under the 10-year flow conditions.

Figure 3: 100-yr Water Surface Elevations under Proposed Conditions
