Codornices Creek
Fish Passage and Habitat
Improvement Project

Conceptual Restoration Plan
San Pablo Avenue to Monterey Avenue

Codornices Creek
Berkeley, California

May 2005

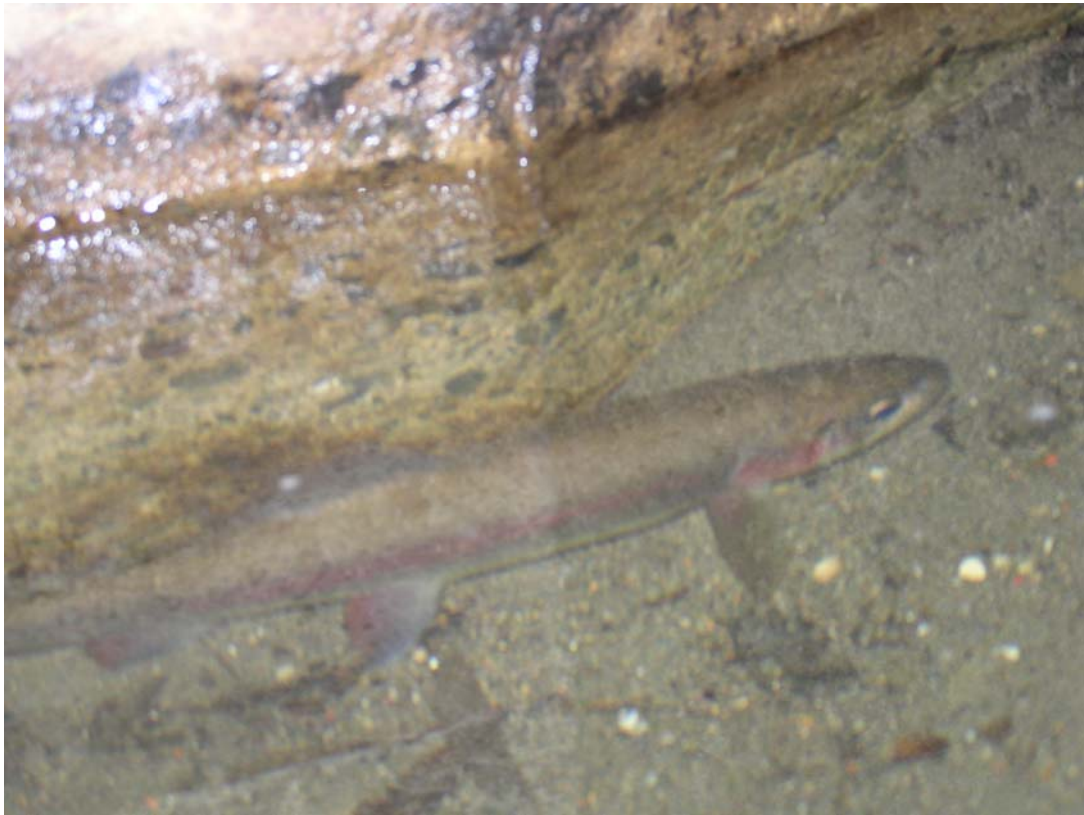
Figure 3. *O. mykiss* seen in the Cornell Avenue Culvert in Berkeley/Albany, California in November 2004.

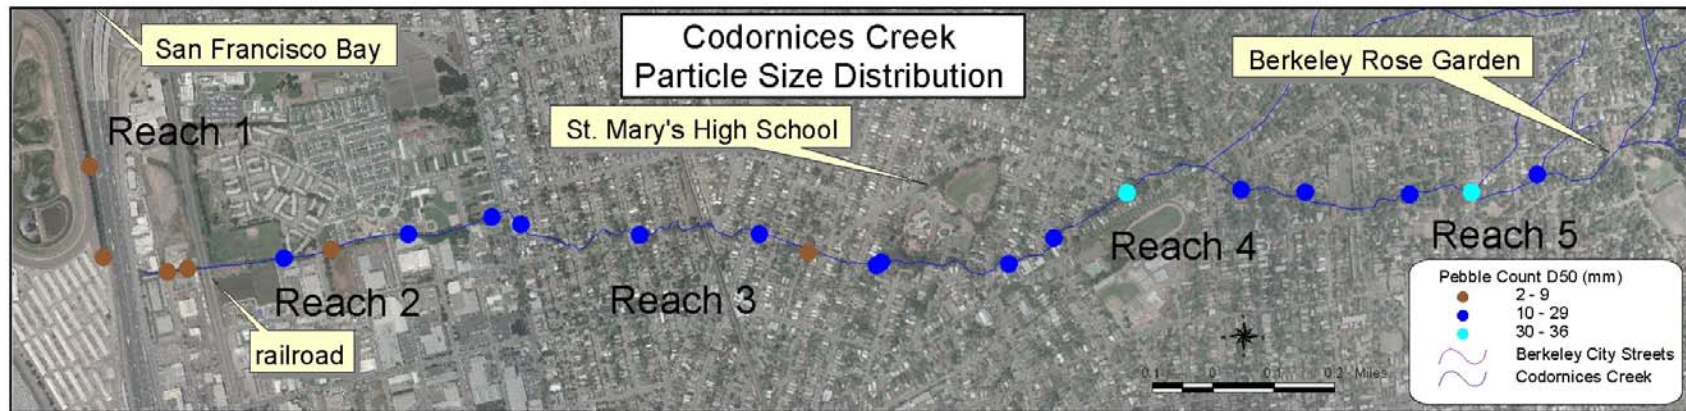
Figure 4. Median gravel size (D_{50}) for Codornices Creek as determined through Wolman pebble counts conducted in 2003. Areas of suitable (blue) and unsuitable (brown) gravels are indicated.

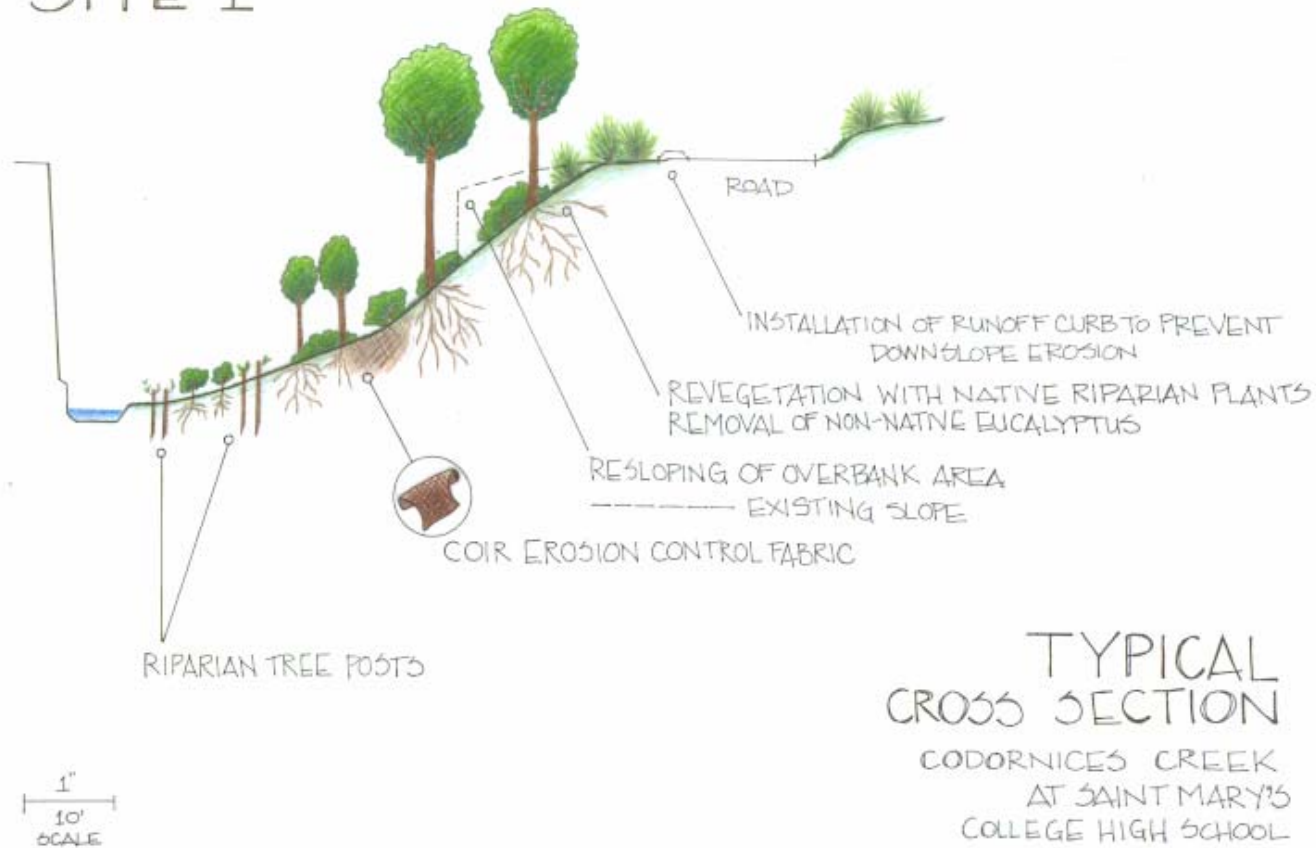
SITE 1

St. Mary's College High School is located along the top of the right bank, downstream of the Albina Avenue Bridge. The channel in this reach is incised with top of slope elevations 30-35 feet above thalweg elevations. Vegetation is comprised largely of non-native and invasive species. A stand of approximately 30 mature Eucalyptus trees dominates the right bank, while the left bank (private property) is covered with cape ivy. Currently erosion is undercutting three eucalyptus trees/stumps along the right bank, which are in danger of falling (Figure 17). When this occurs a significant load of sediment will be contributed to the system. Erosion has created a "lip" of soil which extends along the top of bank. Additionally, the school's paved access road which runs parallel to the top of slope appears to be contributing to the bank's instability. Runoff may be creating downslope erosion.

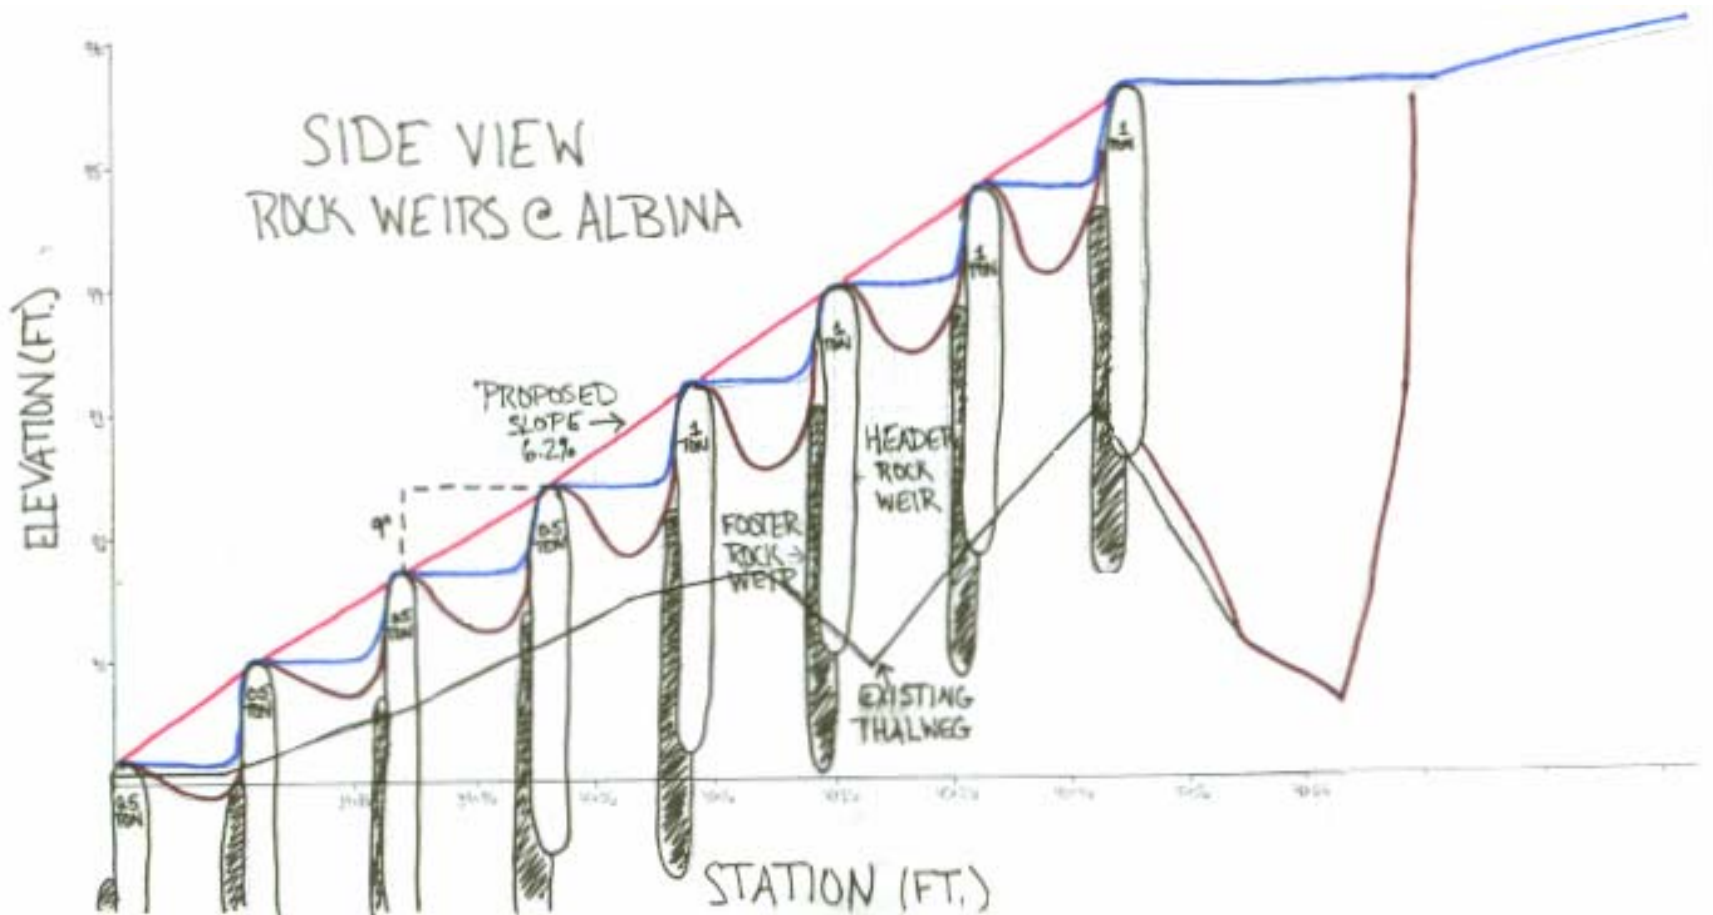
The Albina Street crossing is a concrete bottom bridge that essentially acts as a box culvert across the creek. At the downstream end of the concrete bridge crossing, there is an approximate 3 foot vertical barrier due to the formation of a scour pool from the bridge outlet (Figure 19). This forms an almost total barrier to fish passage at this location. Currently this jump acts as the limiting barrier for upstream migration (Kier, 2004).

Figures 20 and 21 show profiles of the proposed step-pool system for Alternatives A and B. The maximum height of the steps will be approximately 8 inches to allow for adult and some juvenile fish passage. Pool lengths are on the order of 10 feet. The steps will be constructed of a combination of half and one ton boulders placed across the channel in a

Figure 20. Profile of Alternative A step-pool system proposed to modify the existing fish passage barrier at the Albina Avenue Bridge in Berkeley, California. This design involves the placement of eight rock cross-vein weirs which create a series of steps and slightly backflow the bridge crossing.

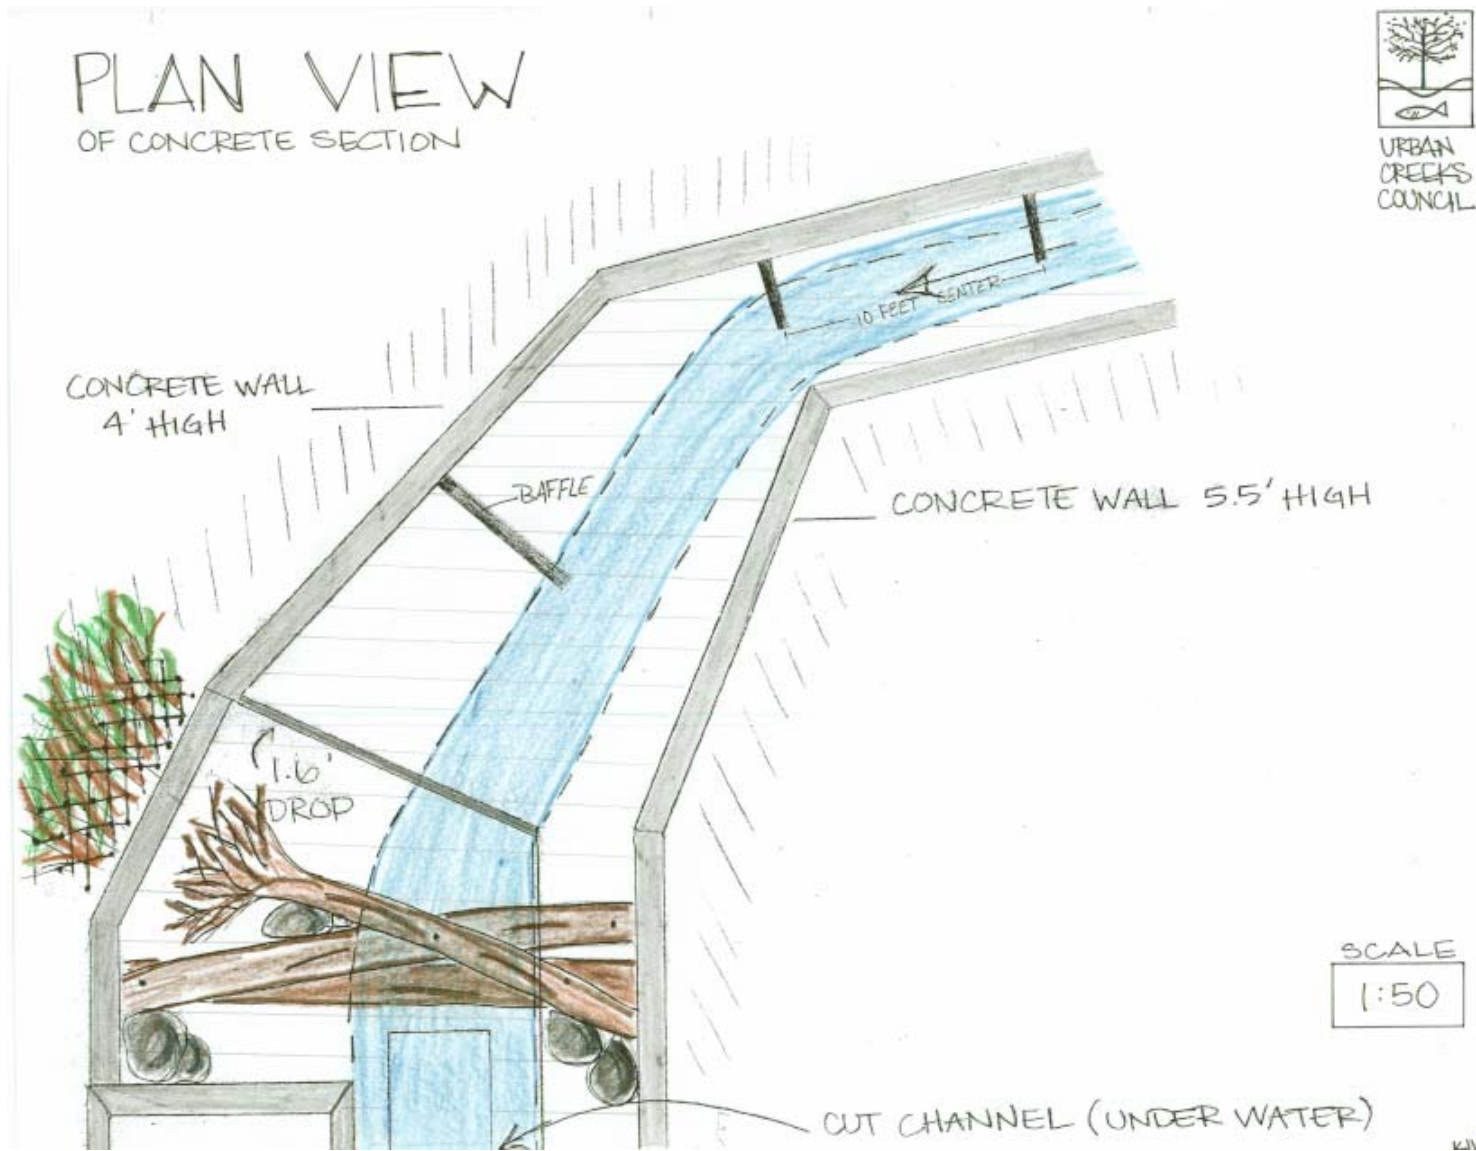
There is an approximate 230 foot section of straightened, concrete-lined channel 224 feet upstream of the Albina Street Bridge. At the downstream terminal of this concrete section there is a vertical step, approximately 1.6 feet in height (Figure 22). Together, the height of the step and the concrete channel section prone to high velocities and low flows, form either a partial or total barrier to fish passage.

The proposed barrier modification to this section includes the construction of low 6-inch cross-baffles along the left bank wall of the concrete channel. In addition, an engineered log structure, or equivalent stepped sections, will be required below the concrete section to bridge the step barrier. Figure 23 shows a plan view of the proposed barrier modification and Figure 24 a cross-sectional view of the engineered log structure.

Figure 23. Plan view of engineered log structure and baffles to be installed to modify the concrete channel which acts as an existing barrier to fish passage.

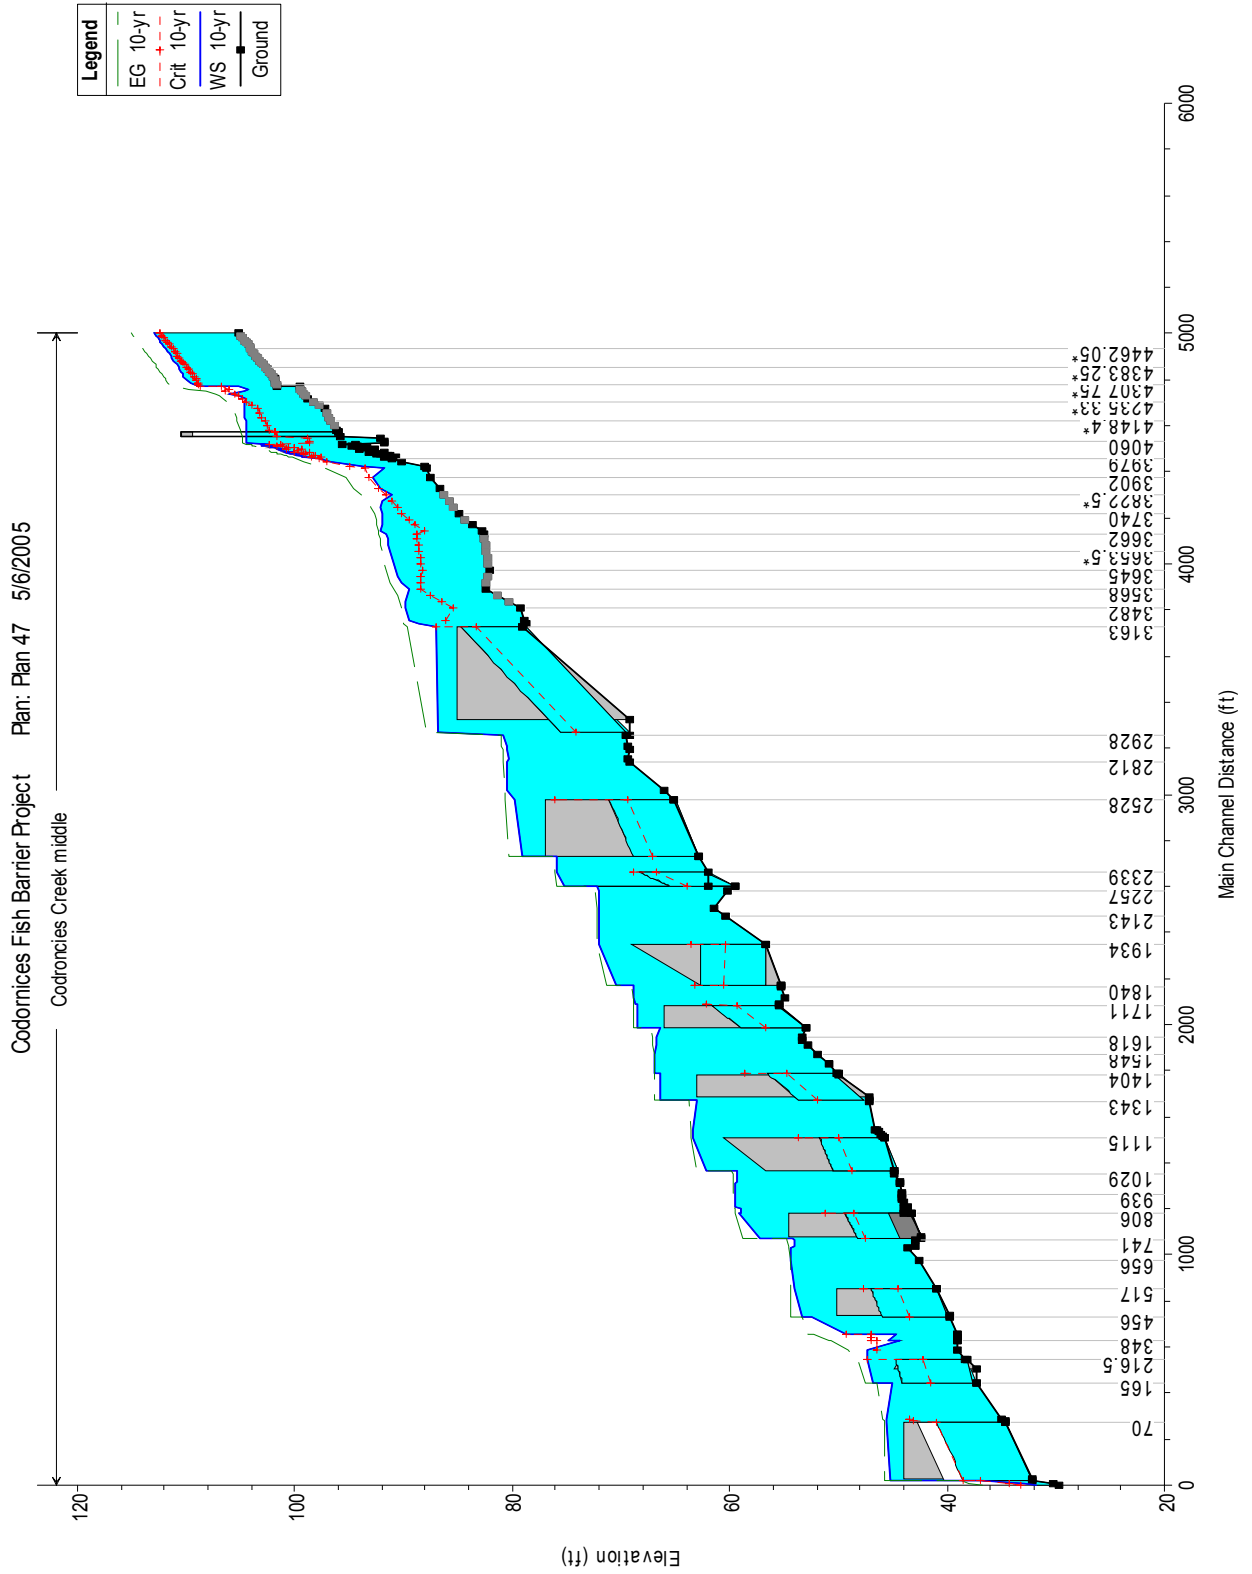
Figure 3 shows the 100-year calculated water surface elevations through the project site under the proposed restoration conditions by analyzing the seven selected culverts, using two methods; 1) embedding the culvert to the depth of the baffle and increasing the Manning's n value to 0.04 and 2) increasing Manning's n to a value of 0.07 in accordance with preliminary measurements obtained in baffled culverts by Washington State Department of Natural Resources staff. The results indicate that there would be a rise in water surface elevation of 8- to 15 inches due to the baffle installation in most of the culverts. Since there is no spare capacity in the culverts under current conditions, it is anticipated that baffles might increase an existing flooding problem. Figure 4 shows the water surface elevations under the 10-year flow conditions.

Figure 4: 10-Year Water Surface Elevation under Proposed Conditions
